Inspection Report Minerals Regulatory Program May 22, 2008

Mine Name: Redd Block IV **Operator Name:** Denison Mines

Permit number: M0370046 Inspection Date: April 30, 2008

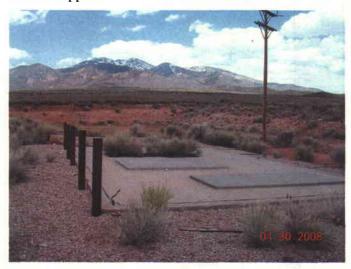
The site consists of two empty water treatment ponds, a flattened area with a concrete pad, an opened cased hole (water monitoring well?) next to the pad, and some power poles with Utah Power labels. This mine has never been opened. I dropped a few rocks in the cased hole, and it took about eight seconds for them to hit the bottom. I did not hear a splash.

Photo 1. This appears to be a water monitoring well, but it was not capped.

The drill hole should be capped.

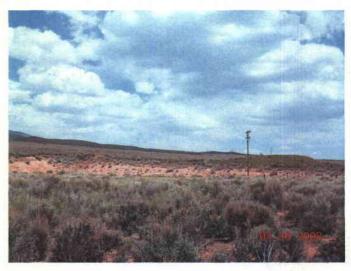
Photo 3. This is one of the ponds.
